VEHICLE ACCIDENT INVESTIGATION

CASE NO. 90-08

TECHNICAL REPORT

NHTSA In-Depth Airbag Accident Investigation Case 90-08
 Accident Date: [REDACTED]-90 | Location: [REDACTED], Arkansas

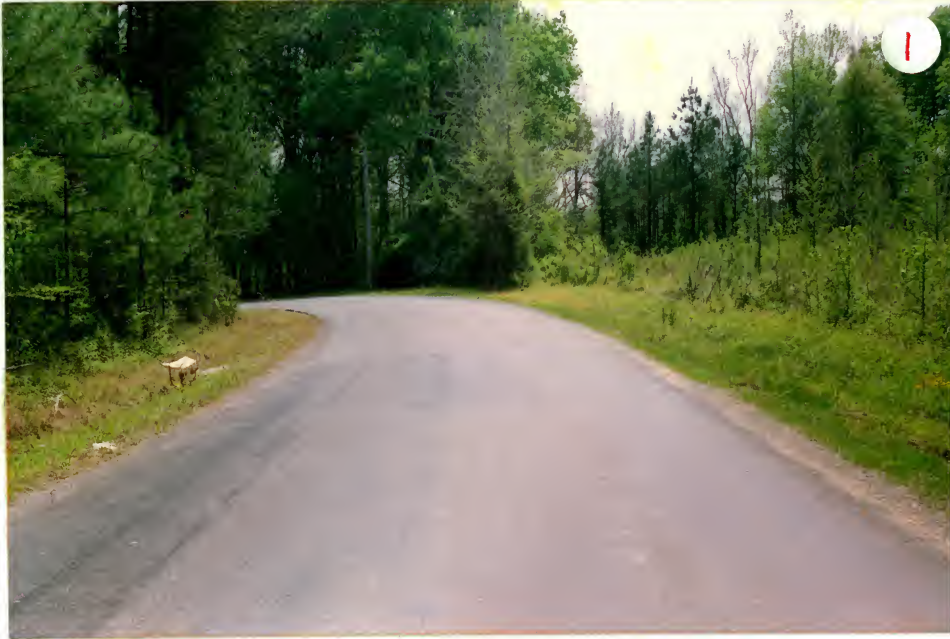
1. Pre-impact direction of travel of the Storm on Road.

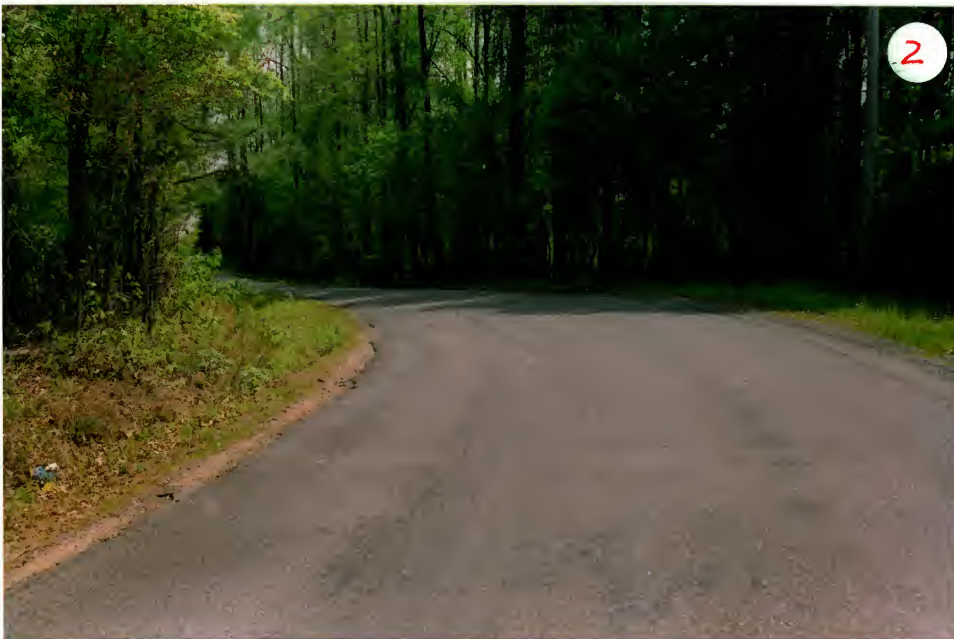
2. Consecutive view of the travel path of the vehicle.

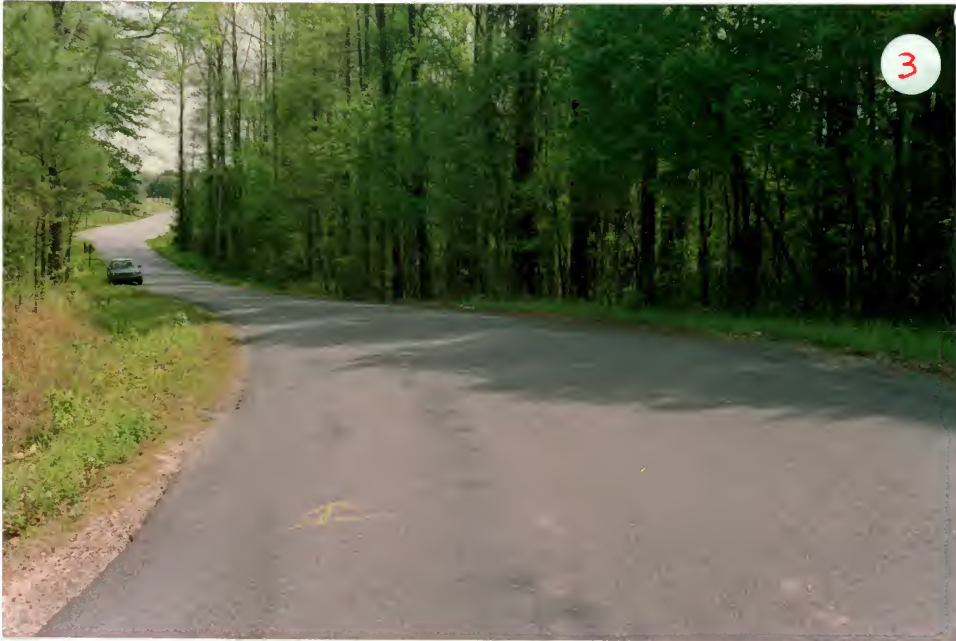
3. Area where the left front skid mark begins.

Evidence at the scene indicates the left front tire of the case vehicle skidded 97.25 ft. on the roadway. The vehicle traveled 36 ft. on the roadside before impacting the first group of small trees. The front bumper impacted at least three small trees in this area with the damage distributed across the entire frontal plane of the vehicle.

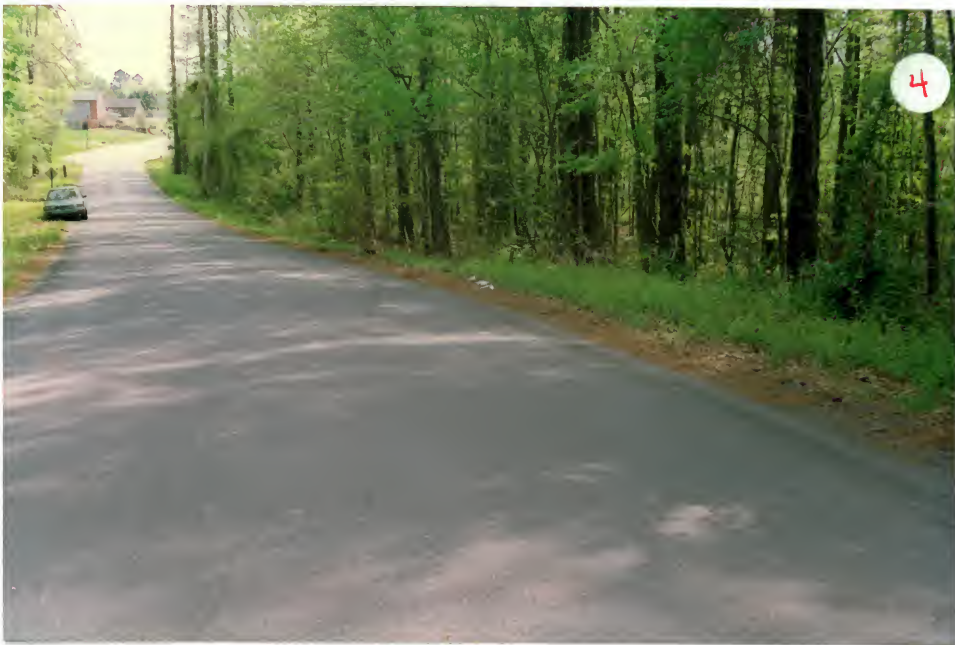
4. Continuation of the left front skid mark.

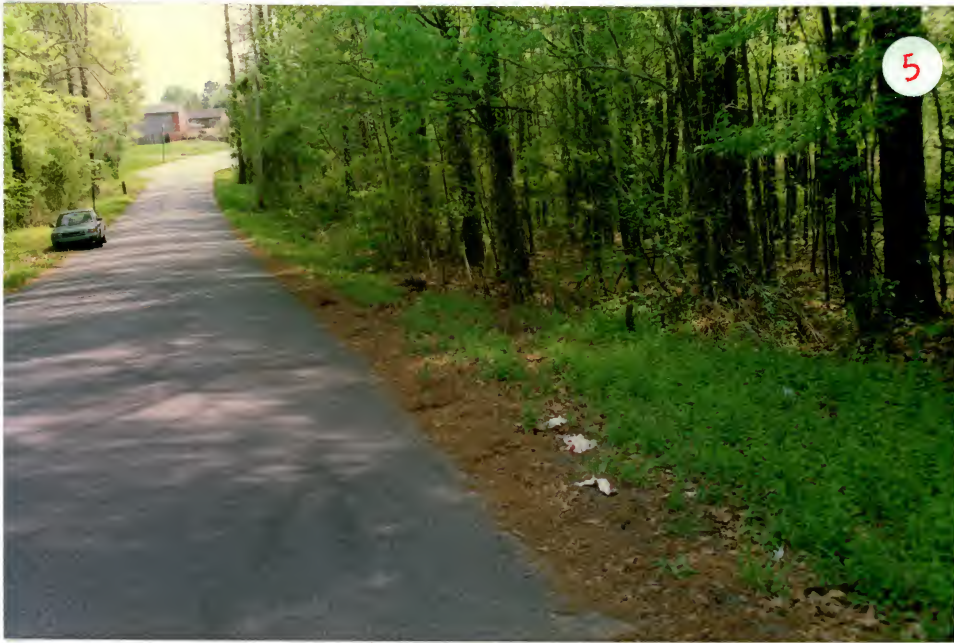
5. Area where the vehicle departs the roadway.

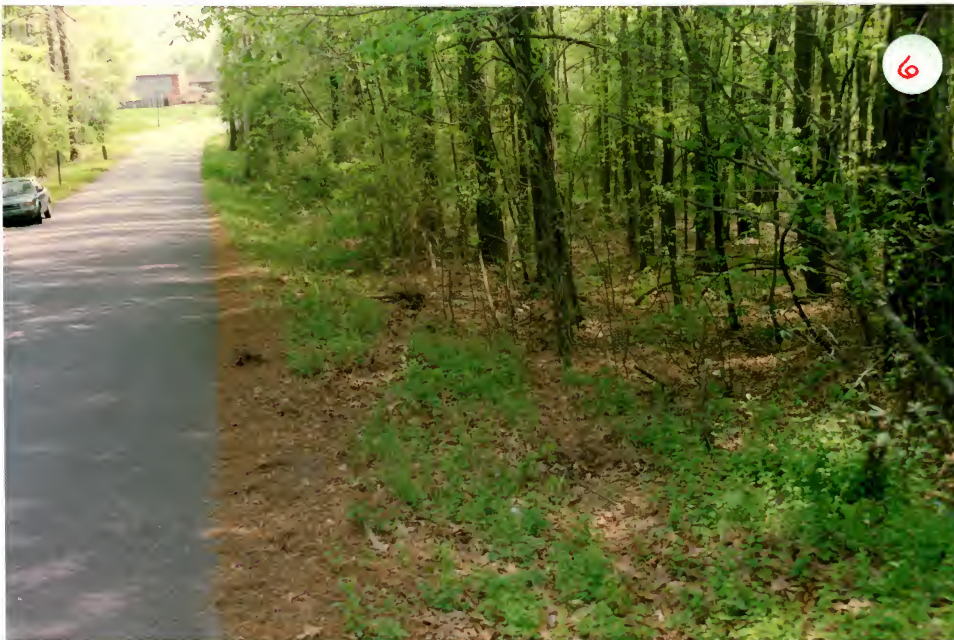
6. Path of travel of the vehicle on the roadside.

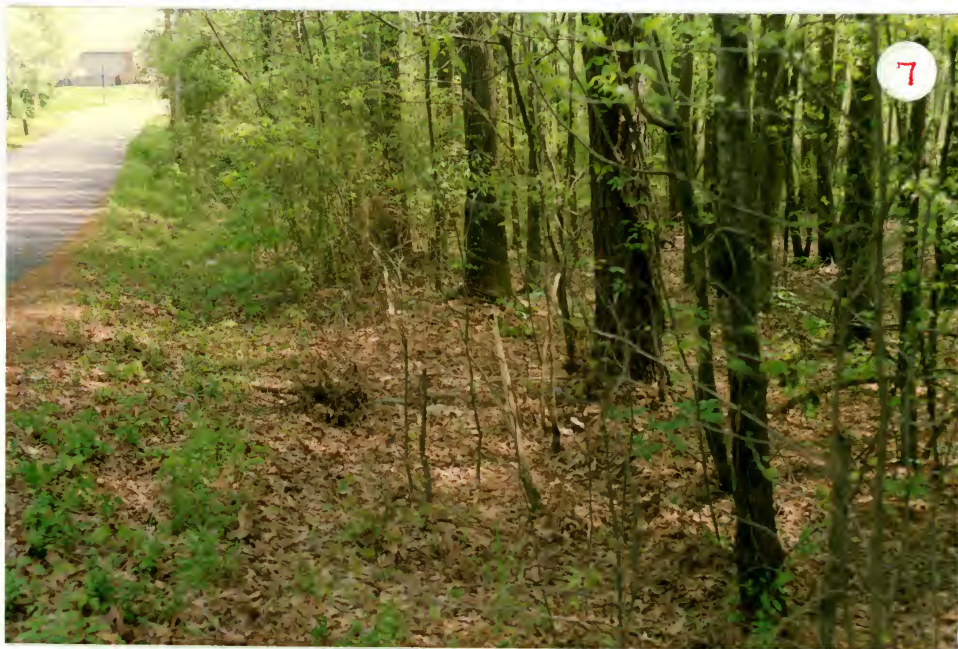
7. View of the area where the Storm impacts several small trees.

The frontal plane of the airbag vehicle impacted several small trees after leaving the roadway. Direct damage from the small trees was distributed across the entire front bumper cover. This damage did not result in enough crush to measure and a Collision Deformation Classification of 12-FDEW-1 was assigned to this impact.

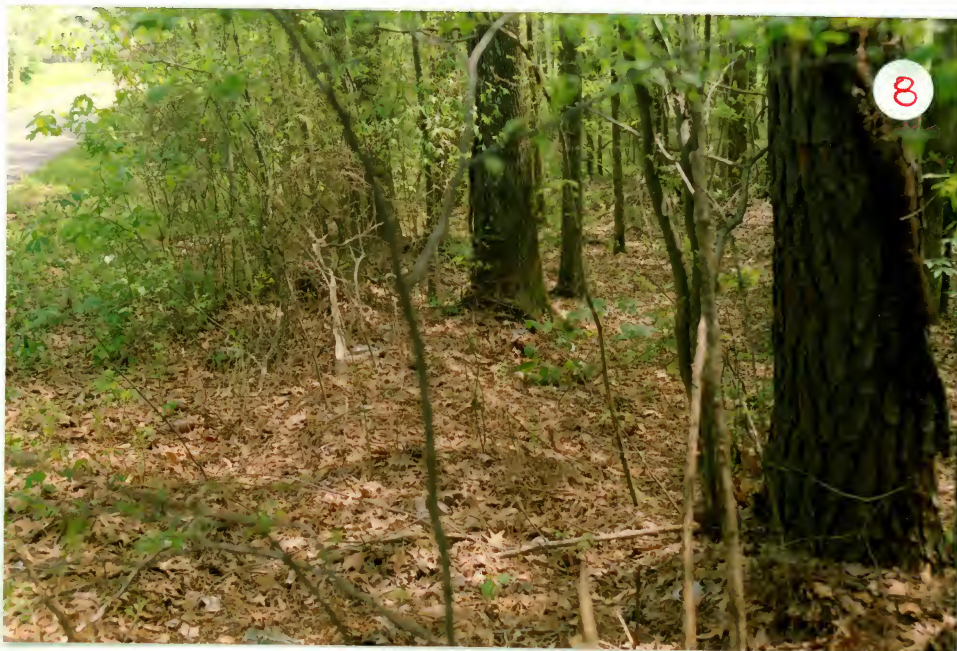
8. View of a large pine tree sideswiped by the vehicle.

The next significant impact was with a larger tree. The right side of the vehicle sideswiped a pine tree. Damage was noted to the right front fender, right front tire and rim, right side door, right side mirror, and right rear quarter-panel from this impact. Again measurable resultant crush was too small to measure. A Collision Deformation Classification of 12-RDAS-1 was assigned to this sideswipe damage.

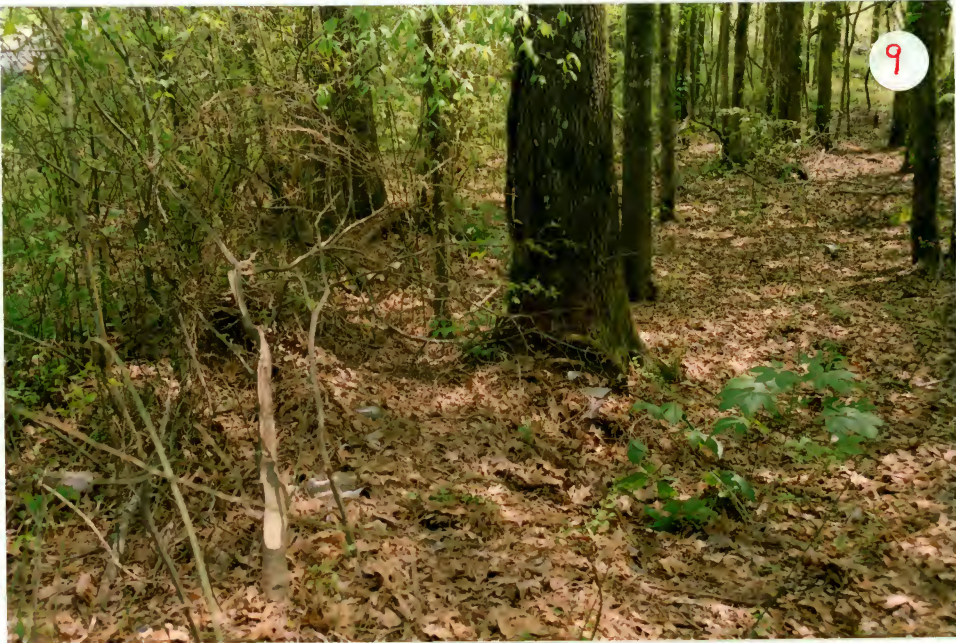
9. Continuation of the vehicle's path to impact with another small tree and a large tree.

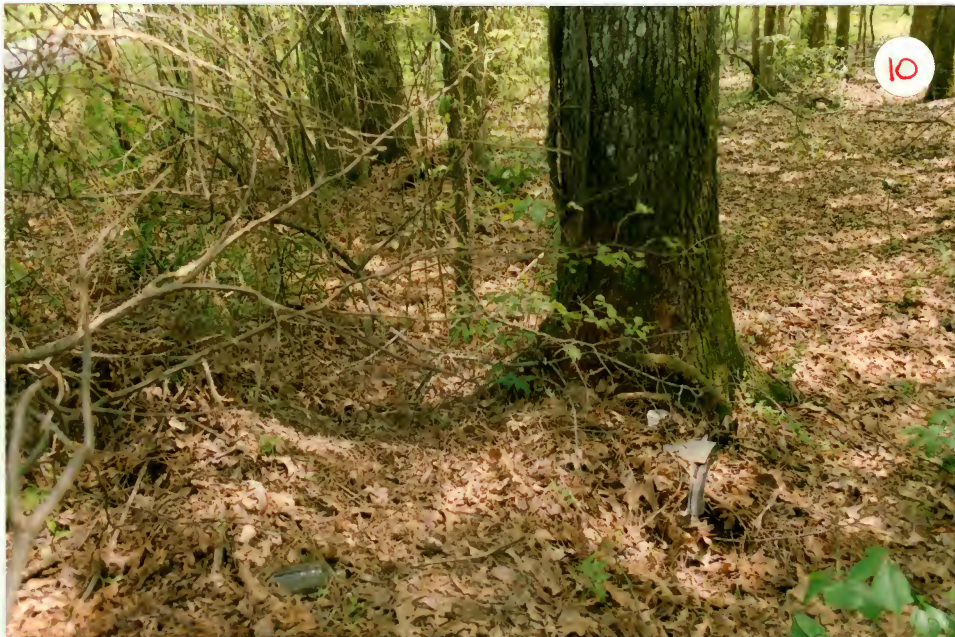
10. Impact area with the large tree. This is where the airbag deployed.

Following the sideswipe the vehicle was redirected counter-clockwise into another large tree. The frontal plane impacted the tree in the most severe impact in the collision sequence. Direct impact damage was located on the right half of the front bumper. Damage was noted to the bumper, bumper cover, right headlamp assembly, hood, and right front fender. Maximum residual crush was measured at the right front corner as 10.25 inches to the bumper. The crush measurements were as follows:

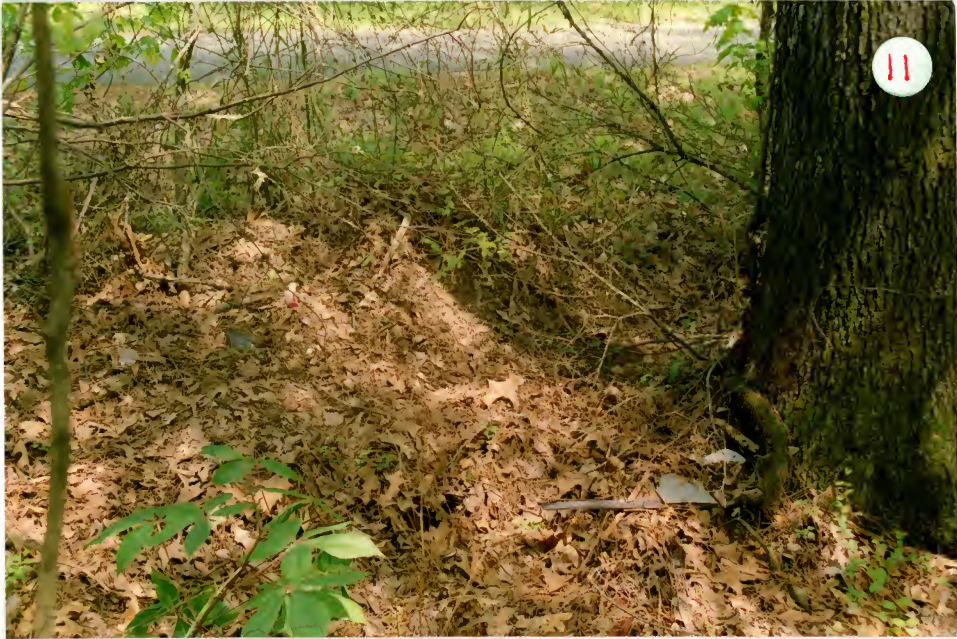
11. Final rest position of the vehicle.

Following impact with the oak tree the vehicle bounced back approximately 8 ft. and rotated clockwise. In all the vehicle traveled 151 ft. from where the initial skid mark began to its final rest position. The vehicle was 13.5 ft. west of the west road edge at final rest. The vehicle was disabled and a wrecker was called to tow the vehicle to a storage facility.

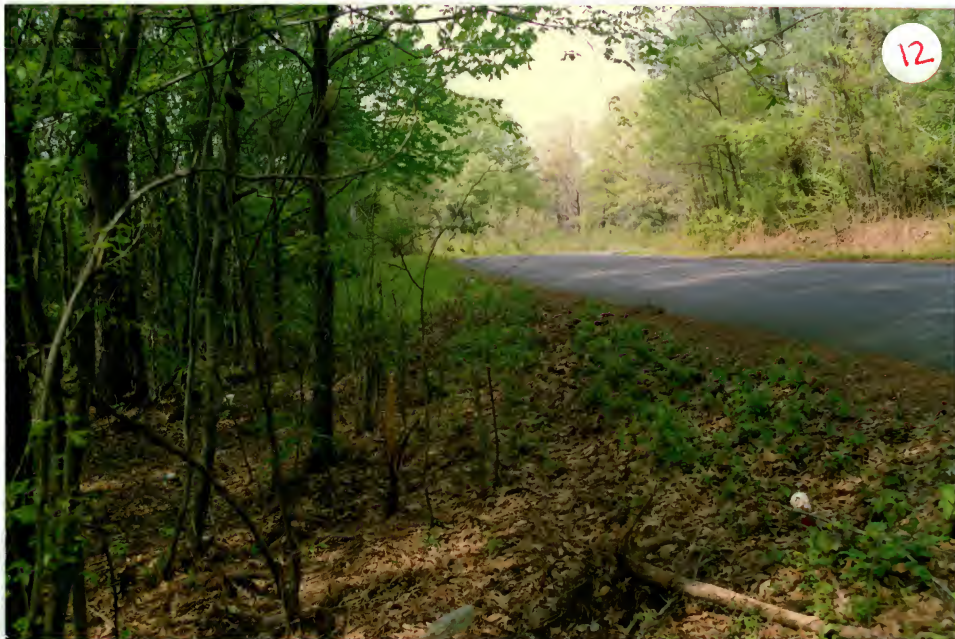
12. Opposite view showing the vehicle's path on the roadside.

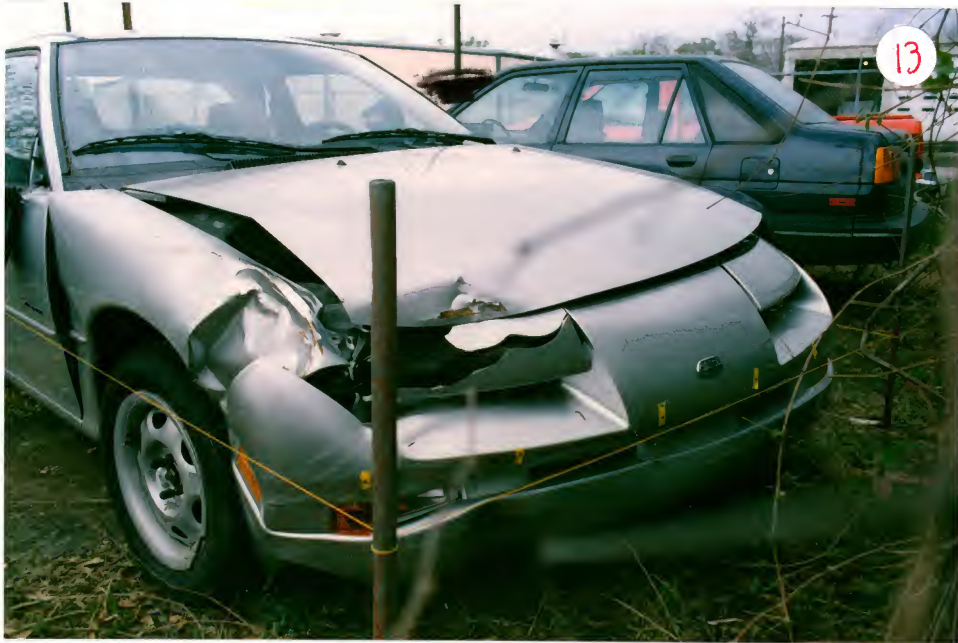
13. Frontal view of the Chevrolet GEO Storm showing the impact damage from the tree.

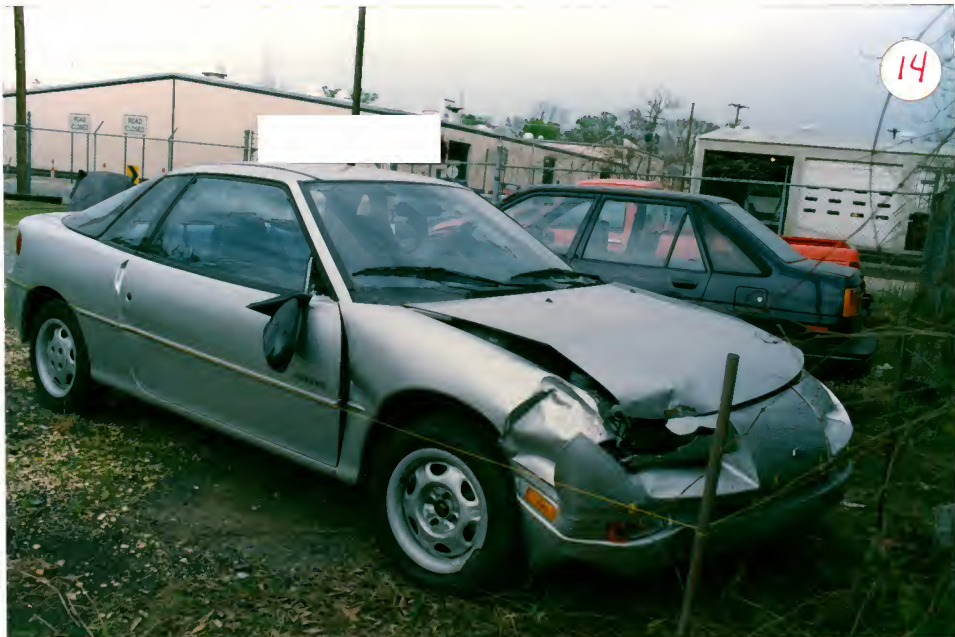
14. Front right view of the vehicle.

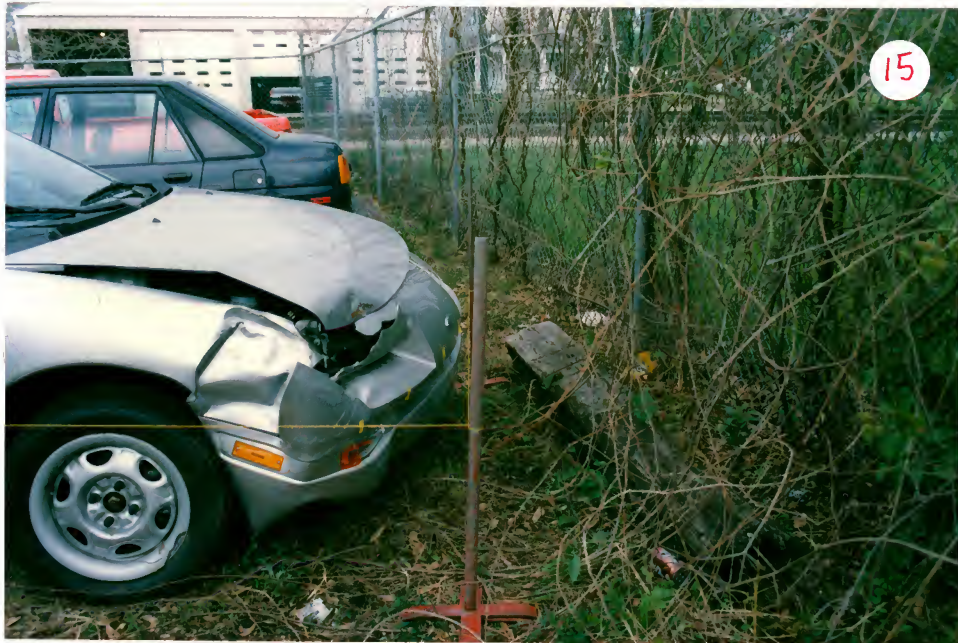
15. Right front view showing the amount of frontal crush sustained in the impact.

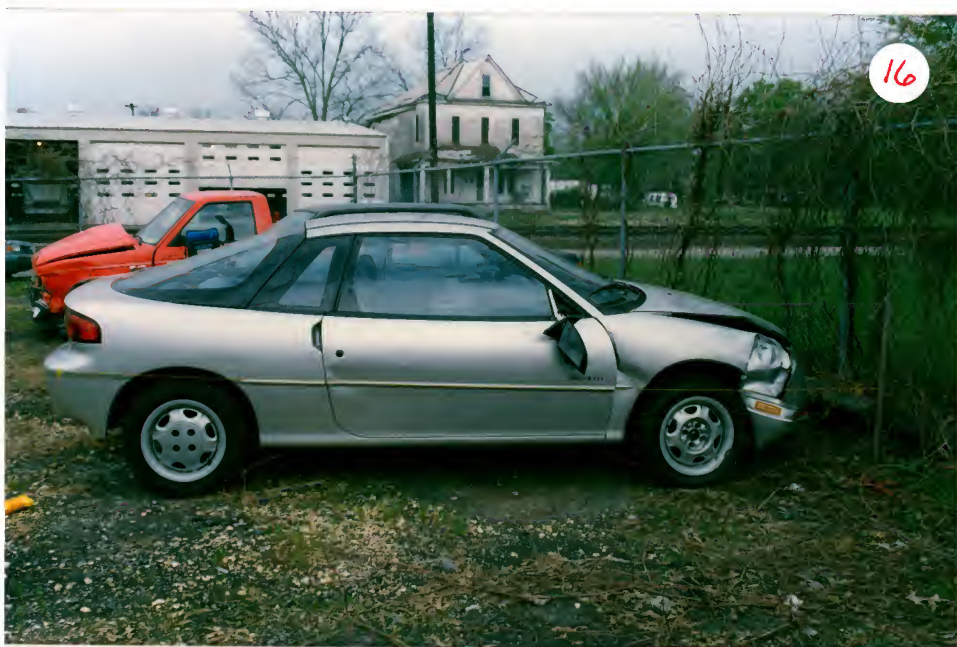
16. Right side view showing the sideswipe damage from the pine tree impact.

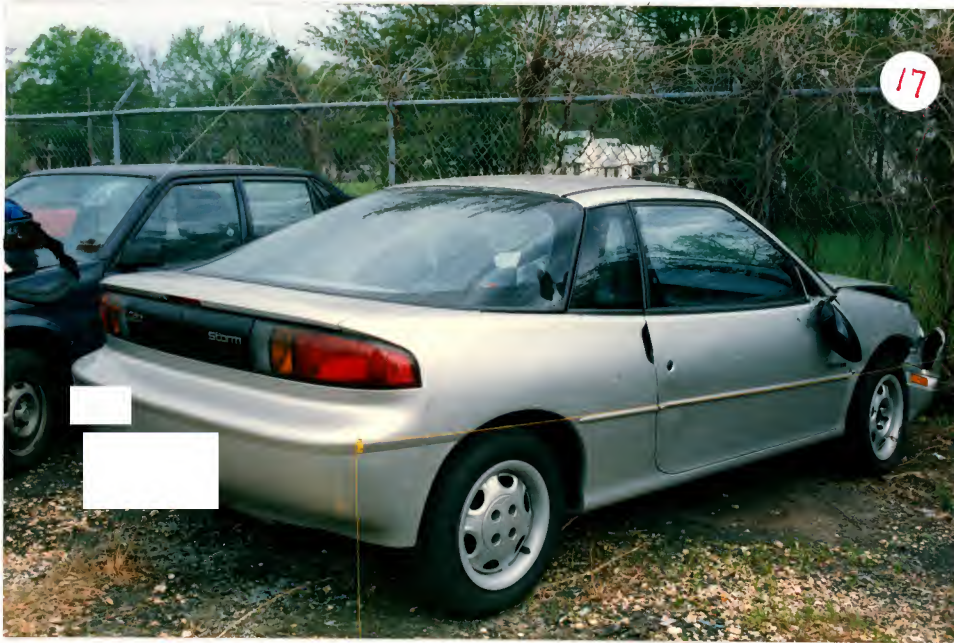
17. Right rear three-quarter view of the vehicle.

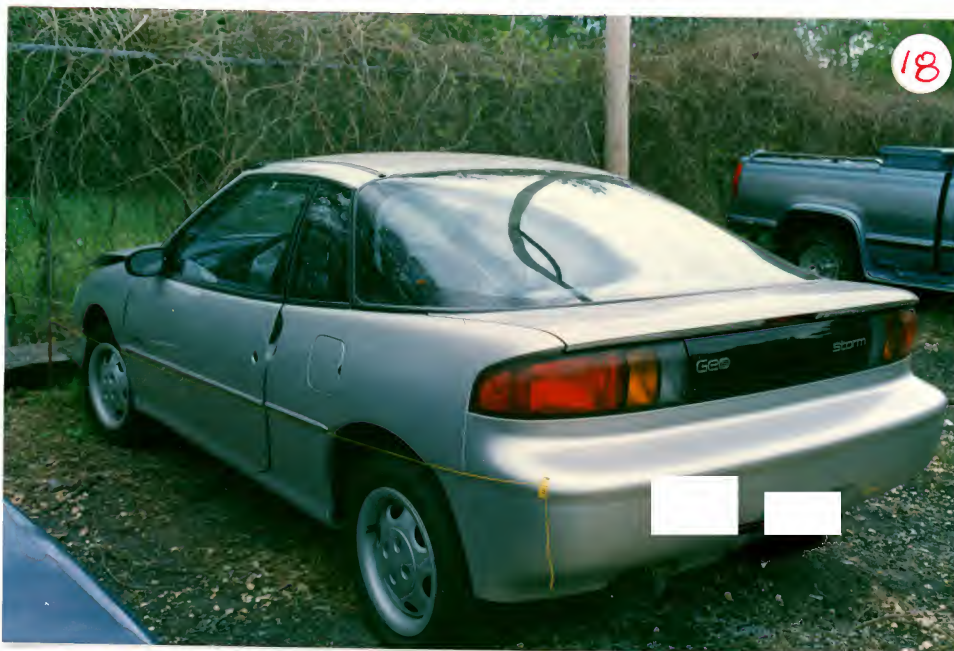
18. Left rear three-quarter view of the vehicle.

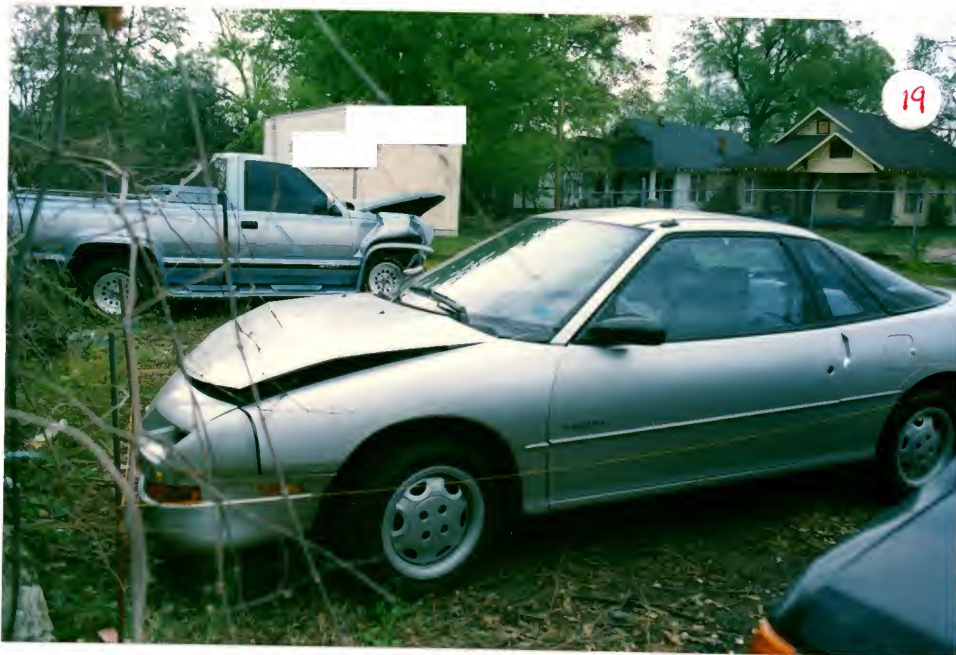
19. Left side view of the vehicle.

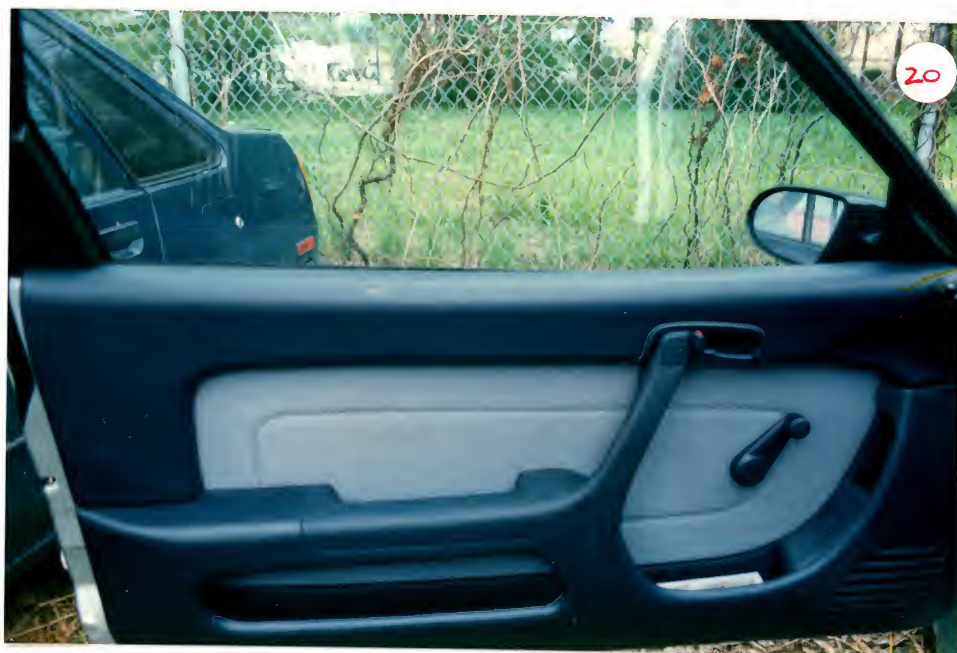
20. Interior view of the Storm showing the driver's door.

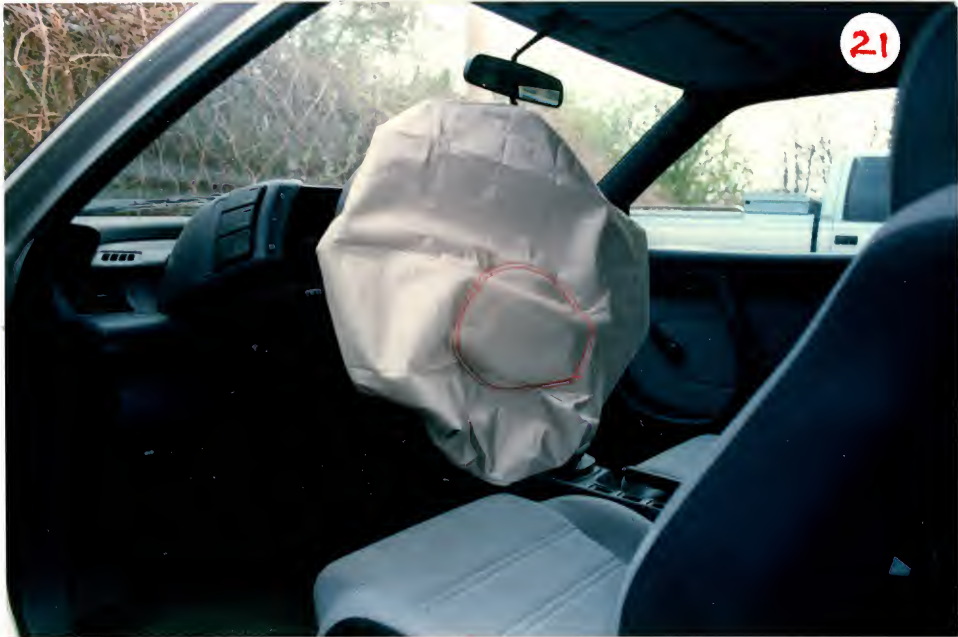
21. Interior view of the deployed airbag module in the Storm.

The interior of the airbag vehicle sustained minor damage as a result of the airbag deployment. The steering wheel module cover separated at the designated perforations. No other damage to the airbag occurred. No occupant contact points were noted and no other interior damage occurred.

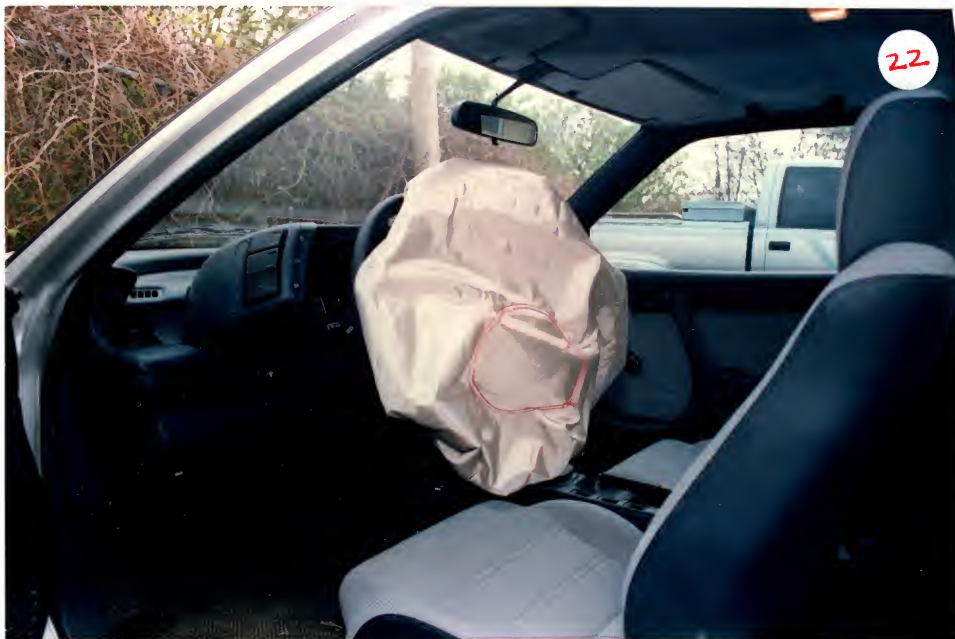
22. Additional view of the interior and deployed airbag. No occupant contact points were found.

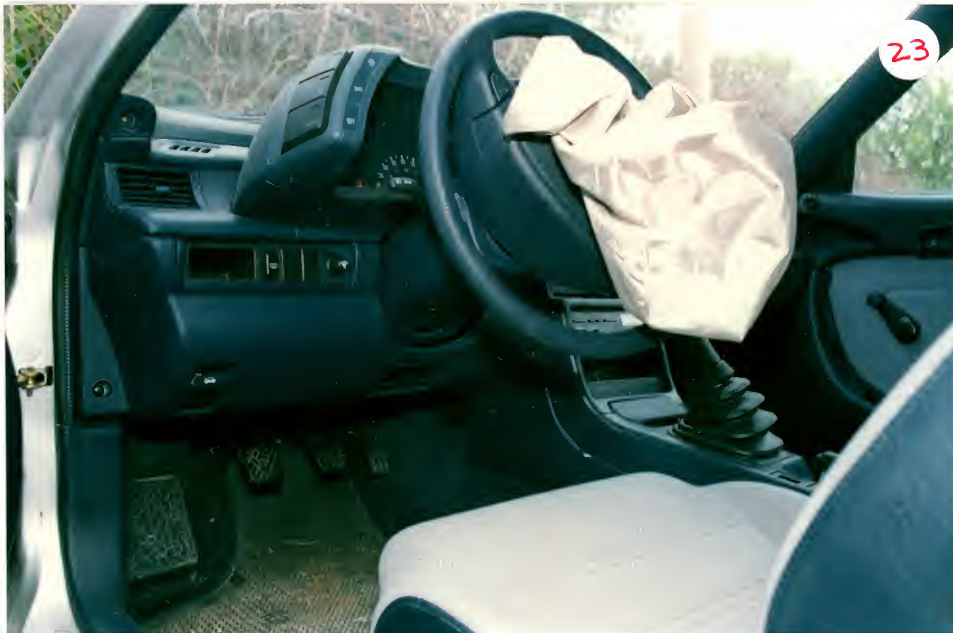
23. View of the lower dash and foot controls.

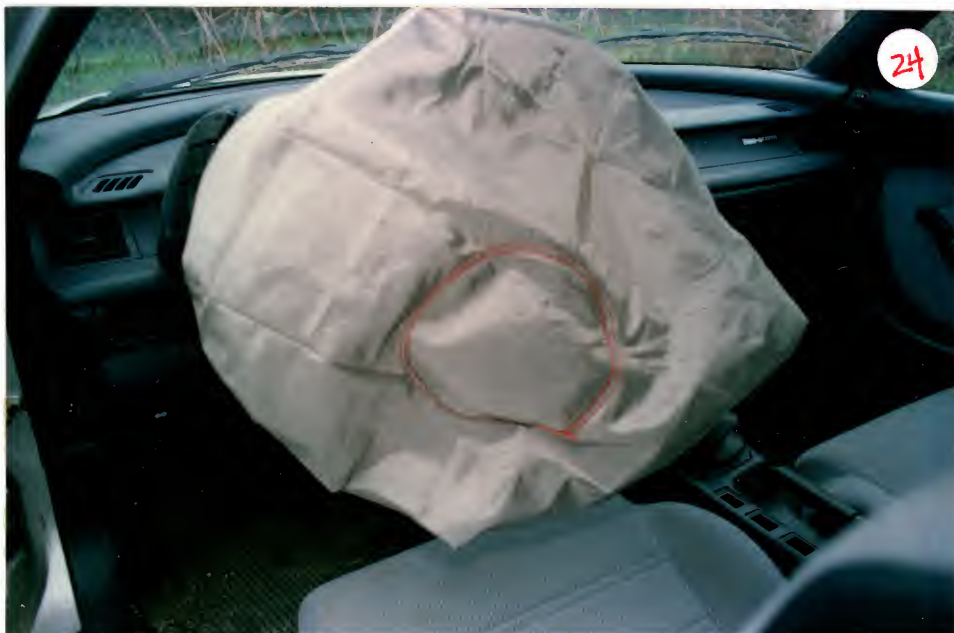
24. Close-up view of the deployed airbag.

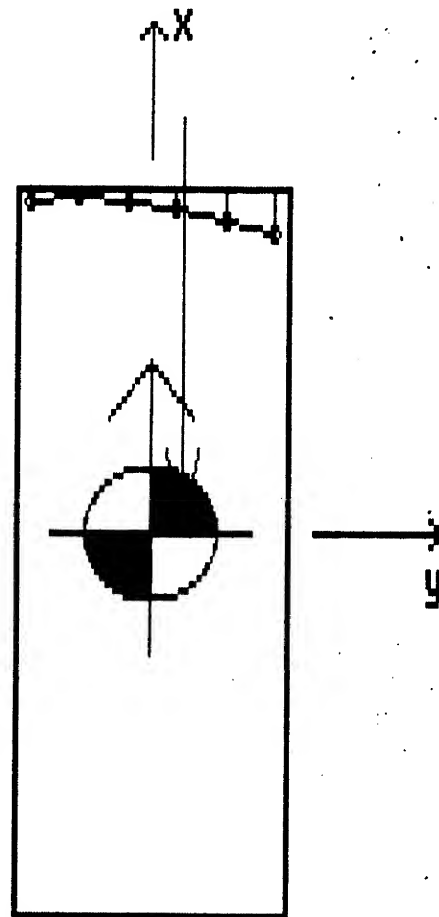
Vehicle No.1

CDC/PDOF: 12FZEW2 -0.1 deg
Max. Impact Force: 29508 lb

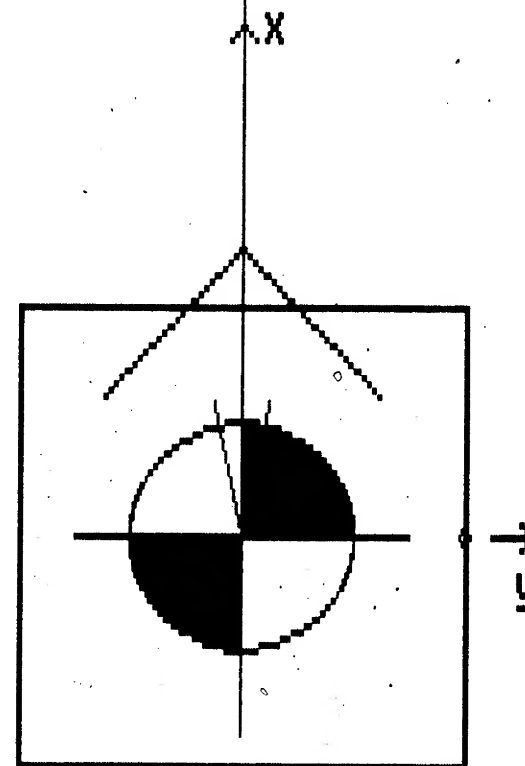
Vehicle No.2

CDC/PDOF: BARRIER 0.0 deg
Max. Impact Force: 29508 lb
